STUDY OF THE FUNCTIONING AND WEAR OF THE TEETH OF THE INTERMEDIATE GEAR OF THE VERTICAL GEARBOX ROLLS OF THE SLABING STATE - 1150

Abstract

Keywords: rolling mill, gearing, types of wear, resource, monitoring.

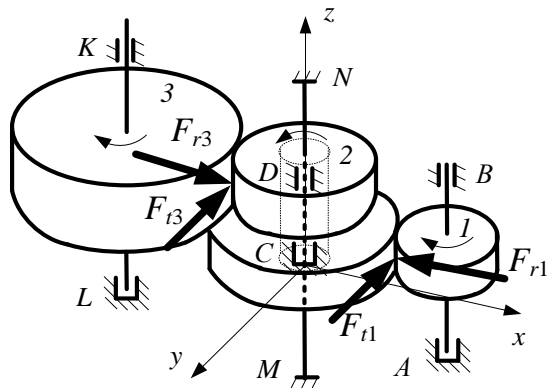
The calculation schemes of the vertical roller drive gearbox and the intermediate gear are presented, respectively, in fig. 3 and Fig. 4.

The problem link in the gearbox under consideration is the intermediate gear 2. A feature of the design of the intermediate gear unit is two pairs of mounted roller bearings (roller conical in the support C and roller spherical in the support D) rotating relative to the stationary shaft in the supports M, N. The immediate object of the study is the second most vulnerable stage of the intermediate gear ($d_a = 848$; $b = 450$; $m = 16$ mm). The axial load G from the weight of the gear is transmitted to the roller conical shafts in support C and are locked on the side of the fixed shaft. Therefore, an asymmetric load on the gear and different stiffnesses of the shafts of supports C and D can cause its skew in two areas (zCx , zCy), as shown in fig. 3.

Which contributes to the formation of a misalignment of the intermediate gear at small angles $\Delta\alpha_1$ and $\Delta\alpha_2$ respectively, in the areas zCx , zCy (Fig. 3). This contradicts assumption #2 and changes the expressions (1) of resistance reactions.

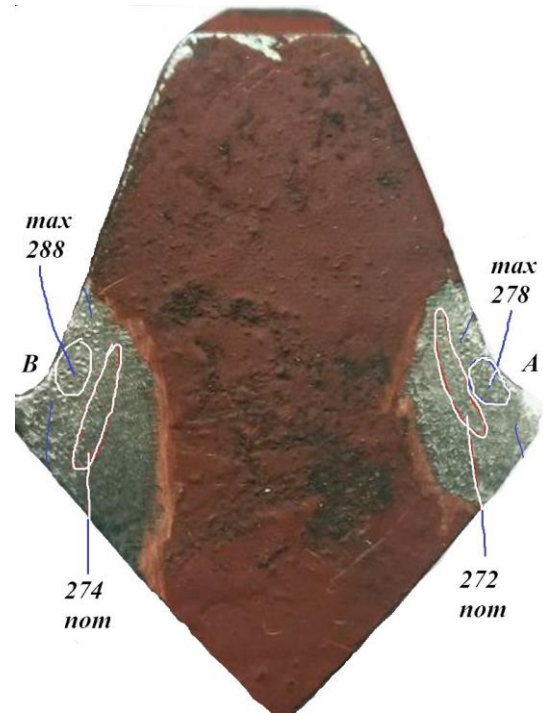
Fig. 15. Tooth end with measured hardness values

The results of hardness measurements in the dangerous zones of tooth depressions on the end surfaces are presented in fig. 15.

Average arithmetic nominal values of hardness (for 3 points at a distance of 5...7 mm from the profile of the tooth) of the end surfaces of the teeth on the A side showed HB nom A = 272 MPa, on the B side - HB nom B = 274 MPa; average maximum (for 3 points) on the side A - HB sr.ma x A = 278 MPa, on the B side - LV average x B = 288 MPa.

The possibility of monitoring the technical condition of gear wheels by the hardness of the working involute surfaces of the teeth in the pole zone and the end surfaces in the zone of the radial transition of the tooth depressions into the involute profile has been proven. An increase in hardness in these zones compared to the nominal hardness at a distance from the contact points and stress concentrators was established. Monitoring of gear wheels by material hardness can be used to develop a method for estimating the residual life of gear wheels.
