VISION-BASED DAMAGE DETECTION OF AIRCRAFT ENGINE'S COMPRESSOR BLADES

Krzysztof HOLAK¹, Wojciech OBROCKI²

In this paper, a new vision-based method for an evaluation of aircraft engine's compressor turbine blade damage is presented. The algorithm developed in the research uses image processing and analysis techniques for detection, localization and evaluation of the extent of compressor blades' damage. An introduction of local pixel intensity standard deviation image (SDI) computed for each image pixel made it possible to perform a correct image binarization and damage detection even for images taken in poor lighting conditions and corrupted by specular reflections, shadows and micro reflections from blade's surface roughness. Fractal dimension (FD) analysis of the blade's edge has been applied for automatic localization of detected damage along the blade's edge. An extraction of damage for computation of its geometrical dimensions was carried out with a help of binary image convex hull complement. The performance and accuracy of the developed method was compared with other image analysis methods. Hough transform for marker detection has been used as a method for scaling. The appli

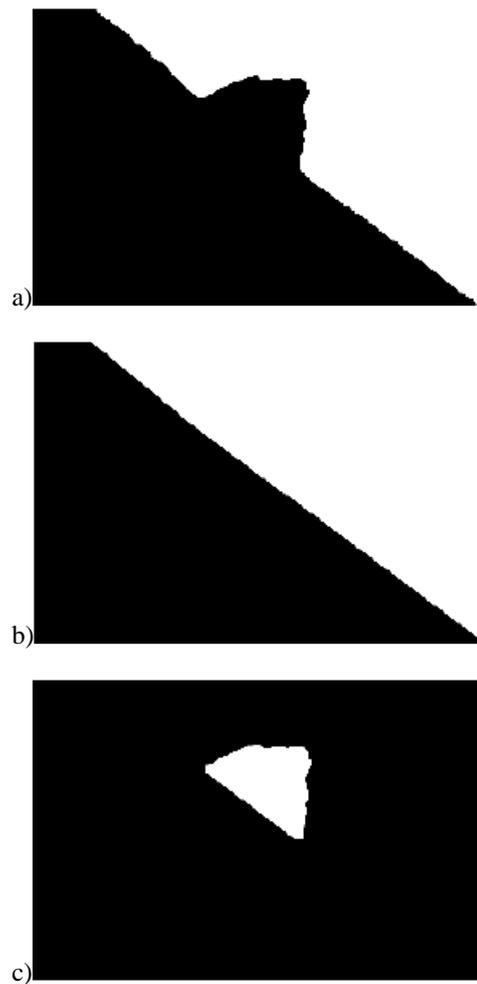
Fig. 1. The damage detection process in the binary image of the aircraft engine's compressor blade, a) the close-up of input binary image with blade segmented out as an object, b) convex hull of the blade's binary image, c) the result of binary image operation. The geometrical shape of damage has been isolated from the rest of the image.

After this operation noise filtering is carried out by the means of morphological operations [18, 19]. The next step of the algorithm is to compute the geometric parameters of the blade's damage. The shape of damaged blade in the binary image is concave because of a notch presence. To identify damage the following process is carried out: the binary image of the damaged blade is completed to its convex shell, then the original binary image of the damaged blade is subtracted from the resulting image. The result of this process is an image with an object corresponding to damage. In the final step, geometrical parameters of damage are computed and its extent is evaluated. To find the location of damage on the blade surface, edge filter is used. It is assumed that the edge of an undamaged blade is approximately a straight line in the image. Every disturbance of the course of this line indicates the occurrence of damage. Therefore, the damage location along the edge of the blade is determined based on the edge's second derivative signal. The last step of the developed algorithm is finding the scale coefficient to obtain damage dimensions in metric units. Special calibration marker in a form of a small chessboard is placed on the blade's surface. Detection of the marker and computation of the scale is performed automatically with the help of Hough transform. First, lines passing through two perpendicular sides of the chessboard square are found and then the corners positions are computed as a points of these lines intersections.

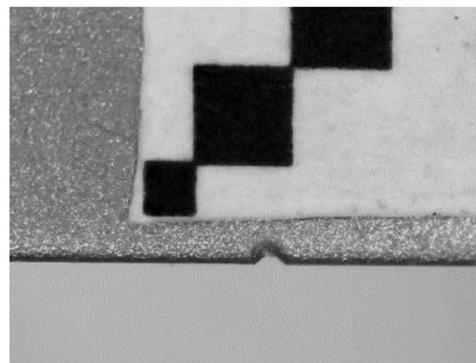
Fig. 2. Close-up of the damage present on the blade's surface. Marker for scale coefficient computation is seen. The corner points of the chessboard squares are found by Hough transform and line intersection computation.

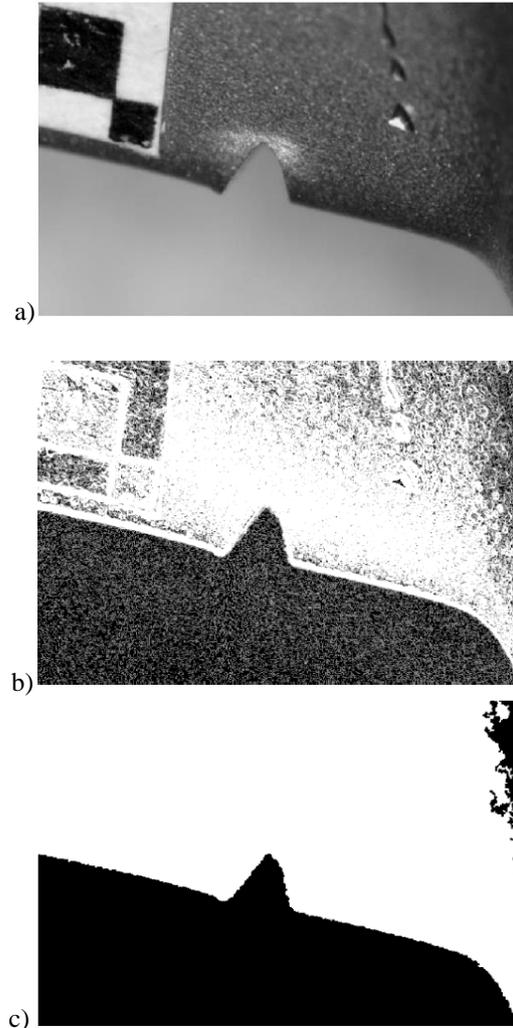
Fig. 3. An application of local pixel intensity standard deviation image filtering, a) the input image – specular light reflection, shadowing and texture due to micro reflections on blade's surface roughness can be seen, b) image processed by pixel level SDI filtering –contrasting brightness of blade with respect to background can be noticed, c) results of binarization of SDI and morphological filtering.

In the image after SDI filtering, low values of standard deviation correspond to black pixels (value close 0) and high values correspond to white pixels (value close to 255). Therefore, image regions of uniform intensity become dark and areas of high pixel variation become bright. Specular reflections and shadows, which are characterized by low pixel intensity variation are changed to dark regions. The blade surface becomes white, due to large variations of its pixels. Next, an image filtered by local SDI filter can be segmented using standard binarization method. An example of an image obtained using proposed methods is shown in fig. 3.

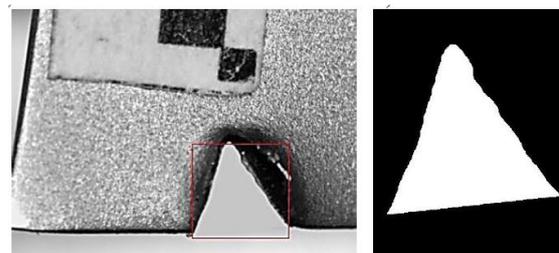
Fig. 4. An example of damage with adverse lighting conditions. The presence of dark shadows and bright blade's surface. Small specular reflections are also visible.

Figure 4. presents an application of the proposed method for damage detection in the image with adverse lighting conditions. The presence of shadow makes it hard to use standard image processing algorithms.

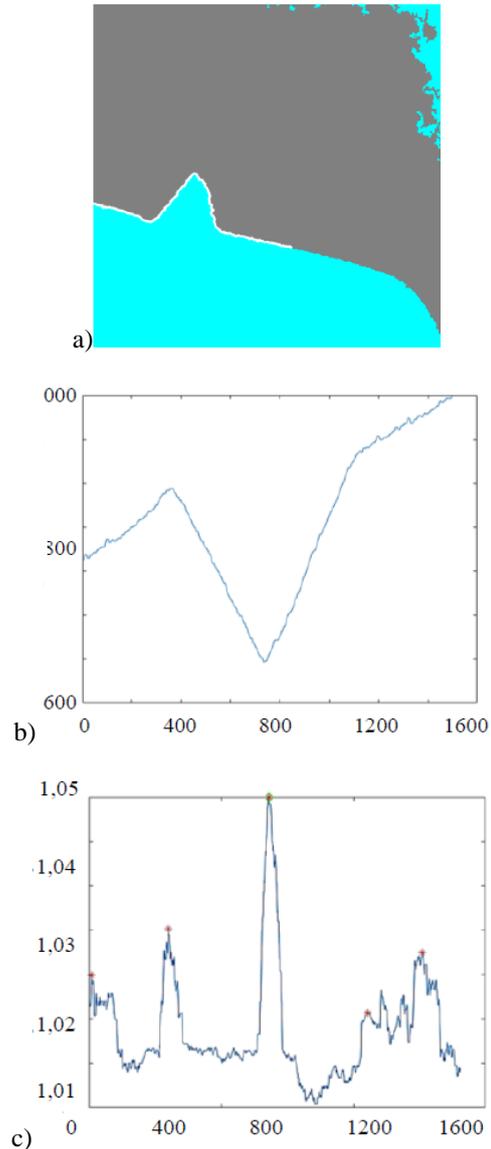
Fig. 5. An application of Fractal dimension method for damage localization, a) binary image of the blade with blade's edge detected, b) representation of the blade's edge curve, numbers on the axes correspond to indices of pixels of the detected edge, c) the result of the Fractal dimension computation on the edge signal – the x-axis corresponds to the number of edge pixel along horizontal dimension of the image, the y-axis corresponds to the value of Fractal dimension.

Katz fractal dimension is equal to 1 for a straight line segment and has values larger than one when a curve deviates from a line. Therefore, this quantity is used to localize damage as a point on the blade's edge at which the deviation from a straight line is the largest. Example of the application of the method is shown in figure 5.

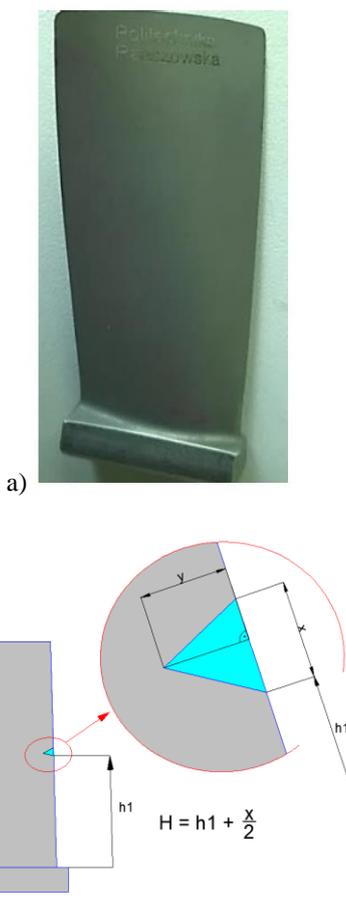
b)
Fig. 6. Research material investigated in laboratory experiments, a) an example of the blade of the first stage of TWD-10B/PZL-10S aircraft engine compressor, b) schematic drawing showing the geometric parameters of notch damage measured in the experimental investigation.

The developed damage detection, localization and evaluation method was verified experimentally on a set of 16 damaged compressor's turbine blades (Figure 6a) of the TWD-10B/PZL-10S aircraft engine that propels the aircraft AN-28. Damage was introduced to the blades' surface in a form of a triangular notch. The referential geometric dimensions of the damage were measured manually using a digital microscope Dino-Lite Edge AM7515MZT which provides image resolution of 2592x1944 pixels and magnification values between 20x and 220x (Figure 7). The location of damage was constant in the experiment. Width of the notch ranged from 0,2 to 0,55 mm, and its corresponding depth ranged from 0,04 mm to 0,33 mm. Notch damage geometrical parameters are given in a table 1, in which h_1 - a distance measured from the base of a blade to the damage, x - width of damage, and y - depth of damage (also see Fig. 5c). Images of blades for processing using the developed method were captured by Nikon D5100 digital camera with 16.2 MPix sensor.

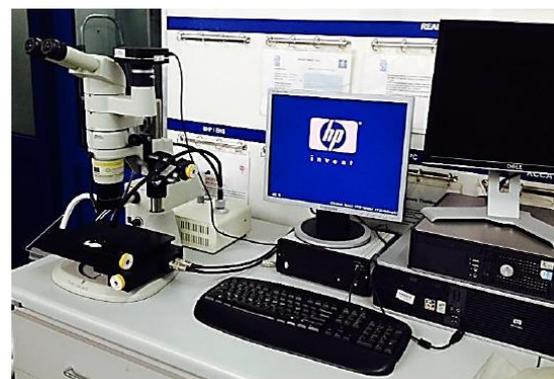
Fig. 7. Lab stand for measurement of the damage width and depth damage at the edge of the blades.
